# REPORT ON FLOOD PROTECTION MEASURES AT THE PUERTO RICO SUN OIL COMPANY YABUCOA, PUERTO RICO

# PREPARED BY METCALF & EDDY DE PUERTO RICO, INC. SAN JUAN, PUERTO RICO

OCTOBER 1990

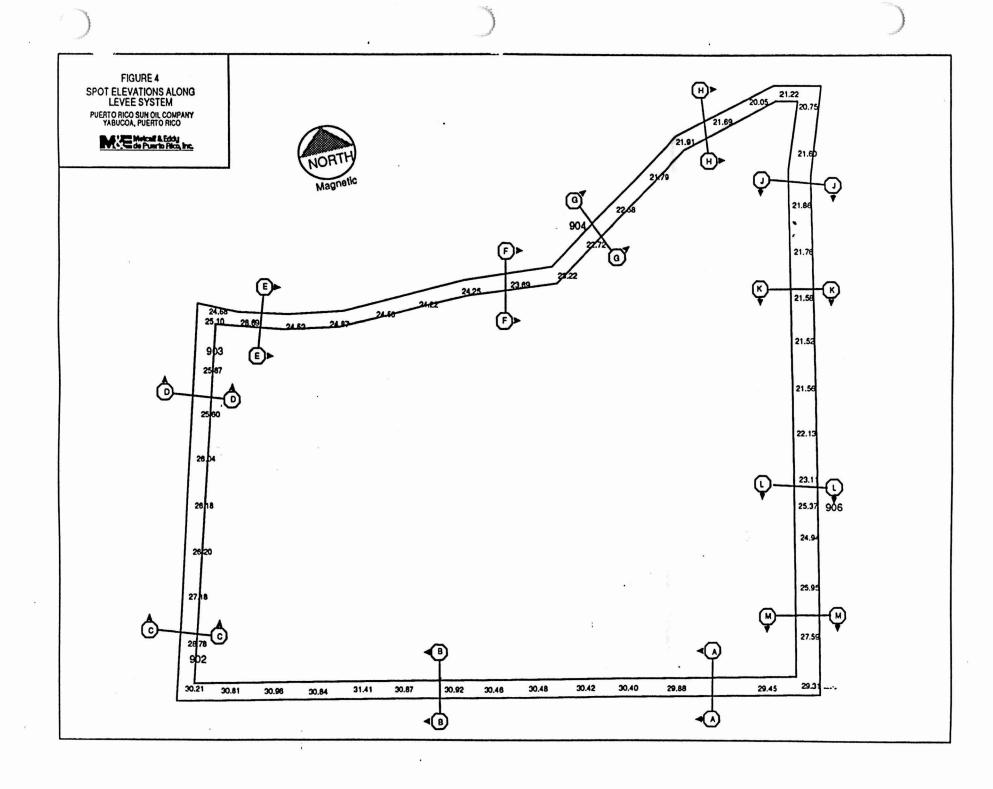
A reduced copy of the spot elevations observed along the levee is presented as Figure 4.

The dike around the Refinery site has elevations between 31.41 feet and 20.25 feet, as per observations made during the weeks of October 1-5 and October 7-12, 1990, by a licensed engineer/surveyor.

A detailed analysis of this data, as compared with the estimated elevation of the 100-year flood event indicates that the levee would have provided sufficient protection against the 1960 rain and flooding event, using the present conditions, Table 1, adjusted to the site.
